[Summary] Current Status of Shika Nuclear Power Station after the 2024 Noto Peninsula Earthquake (as of May 31)

# Current Status of Shika Nuclear Power Station after the 2024 Noto Peninsula Earthquake (as of May 31)

# Occurring Event and Status of Response Up to the Present

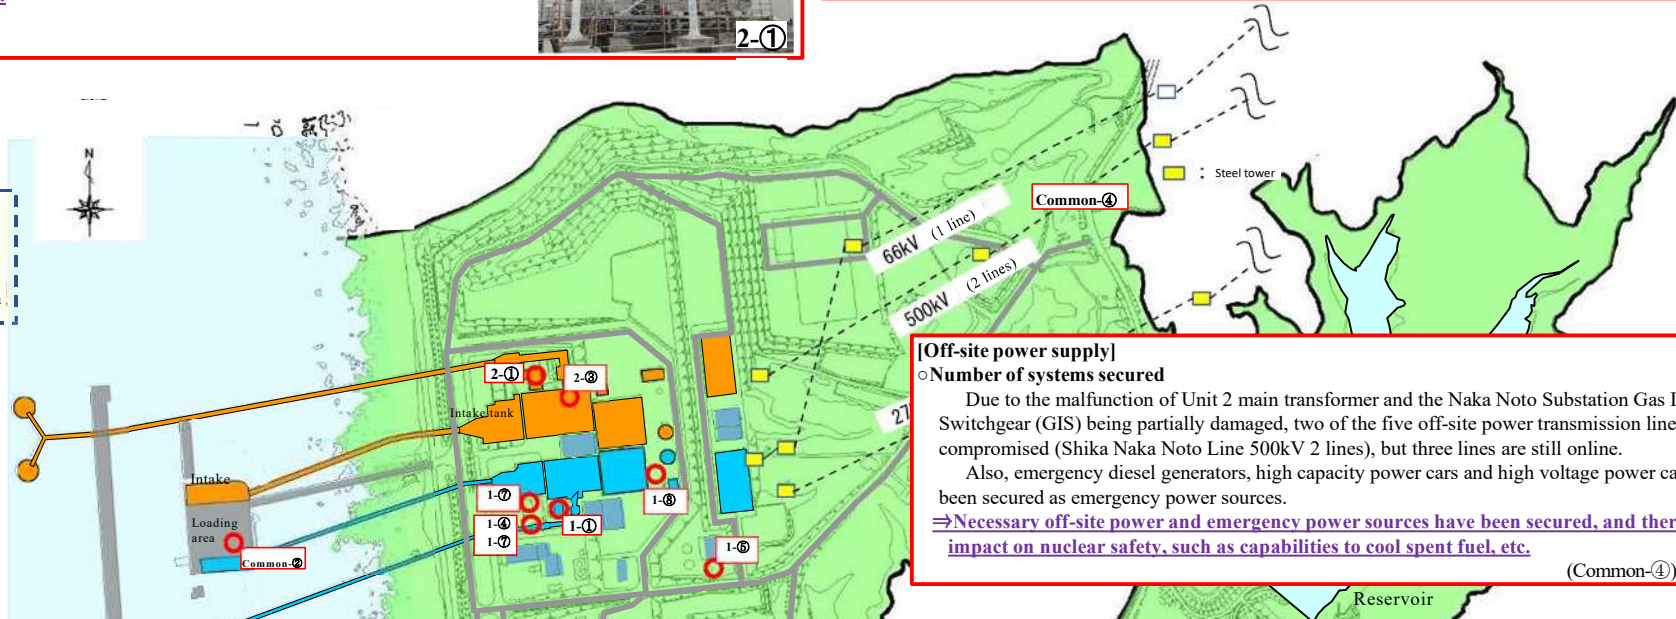
(2-③)

○Turbine annunciator “expansion difference large” set-off

Annunciator “expansion difference large” was set-off at the shutdown Unit 2 low pressure turbine.

Confirmed contact marks between the moving blade and stationary blade of the high and low pressure turbine, and also confirmed damage to the generator rotation detector.

⇒Annunciator was setoff while turbine was shutdown, and does not impact nuclear safety.

Turbine and generator to be inspected around the first half of FY2024, and repairs and restoration to be performed after checking for any damage.
