[Summary] Current Status of Shika Nuclear Power Station after the 2024 Noto Peninsula Earthquake (as of July 4)

Current Status of Shika Nuclear Power Station after the 2024 Noto Peninsula Earthquake (as of July 4)

Occurring Event and Status of Response Up to the Present

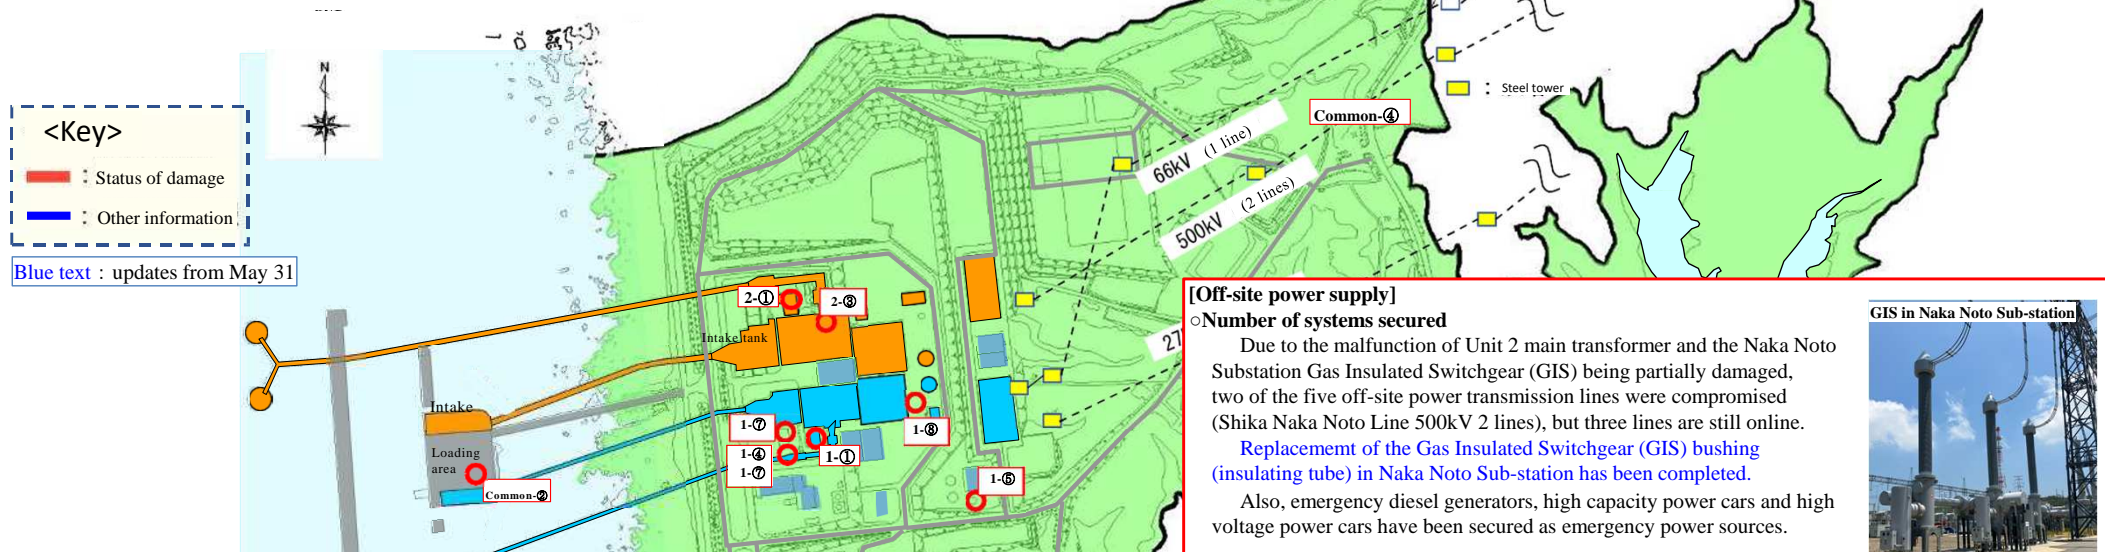
(2-③)

○Turbine annunciator “expansion difference large” set-off

Annunciator “expansion difference large” was set-off at the shutdown Unit 2 low pressure turbine.

Confirmed contact marks between **all of** the moving blades and stationary blades of the high and low pressure turbine, and also confirmed damage to the generator rotation detector.

⇒Annunciator was setoff while turbine was shutdown, and does not impact nuclear safety.

Turbine and generator to be inspected around the first half of FY2024, and repairs and restoration to be performed after checking for any damage.
